Case Study

Project: **Towra Lagoon Protection**
 Location: **Botany Bay, NSW, Australia**
 Client: **National Parks & Wildlife**
 Contractor: **National Parks & Wildlife**
 Consultant: **WBM Oceanics**
 Date: **July 2000**

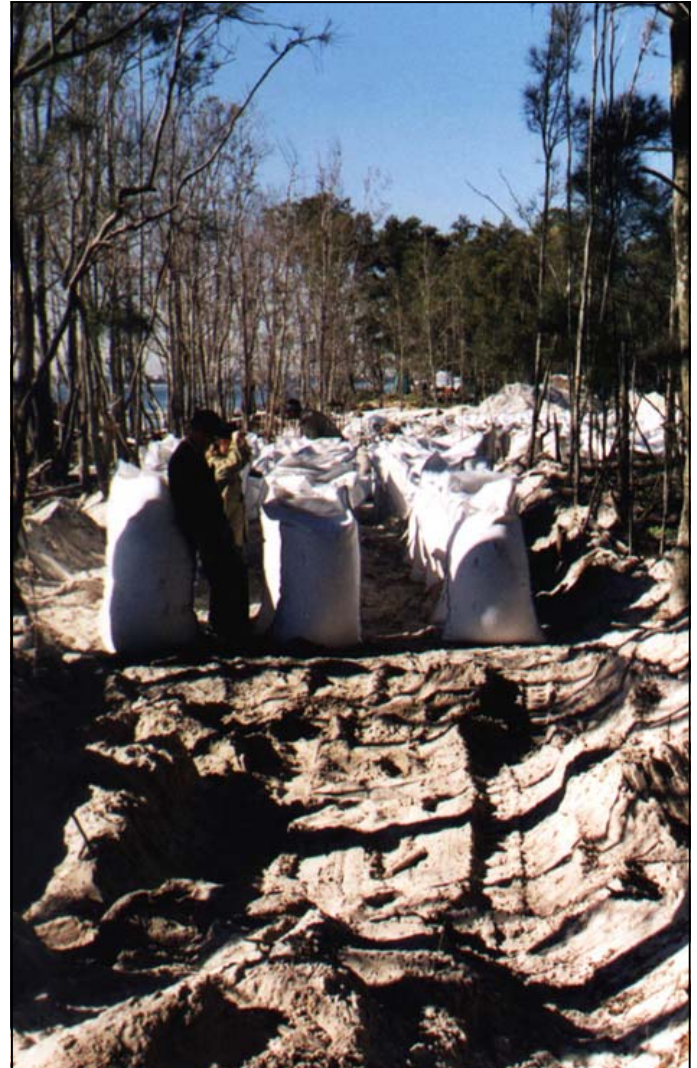
ELCOROCK® containers filled, waiting for placement

In order to provide more reliable protection for the lagoon the NPWS recognised they needed a more substantial structure than the 20kg bags laid previously. However they did not want major earthworks in this environmentally sensitive area and opted for larger 500kg ELCOROCK® containers, which could be placed using a small eight-ton excavator that would limit the damage to the existing flora.

A total of 1200m² of ELCOMAX® 600R and 1300 500kg ELCOROCK® containers were used in this project.

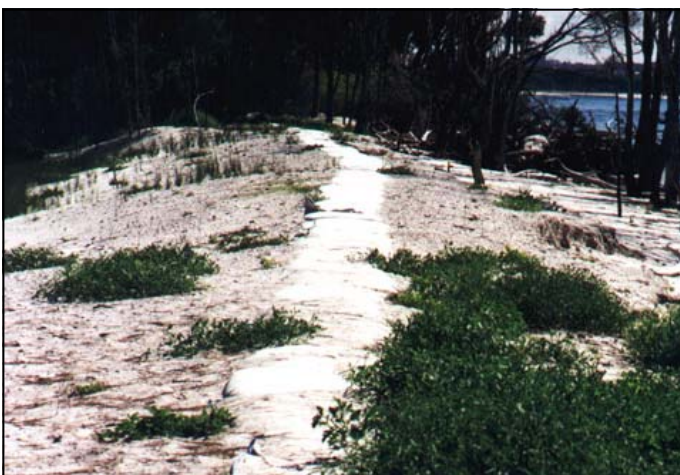
Completed berm

The berm consisted of a sand core encapsulated in ELCOMAX® 600R geotextile covered with an ELCOROCK® armour layer. The local NPWS staff carried out construction of the berm and although the wall was overtopped before it reached full height, which disrupted the works, actual placement of the ELCOROCK® containers went smoothly.
